Quality Assurance and Source Inspection

Contract #: 04-0120F4Cty: SF/ALA Rte: 80 PM: 13.2/13.9File #: 69.28**WELDING INSPECTION REPORT****Resident Engineer:**Siegenthaler, Peter**Address:** 333 Burma Road**City:** Oakland, CA 94607**Report No:** WIR-021674**Date Inspected:** 25-Feb-2011**Project Name:** SAS Superstructure**OSM Arrival Time:** 1500**Prime Contractor:** American Bridge/Fluor Enterprises, a JV**OSM Departure Time:** 300**Contractor:** Zhenhua Port Machinery Company, Ltd (ZPMC), Changxing Island **Location:** Shanghai, China**CWI Name:** See Below**CWI Present:** Yes No**Inspected CWI report:** Yes No N/A**Rod Oven in Use:** Yes No N/A**Electrode to specification:** Yes No N/A**Weld Procedures Followed:** Yes No N/A**Qualified Welders:** Yes No N/A**Verified Joint Fit-up:** Yes No N/A**Approved Drawings:** Yes No N/A**Approved WPS:** Yes No N/A**Delayed / Cancelled:** Yes No N/A**Bridge No:** 34-0006**Component:** OBG**Summary of Items Observed:**

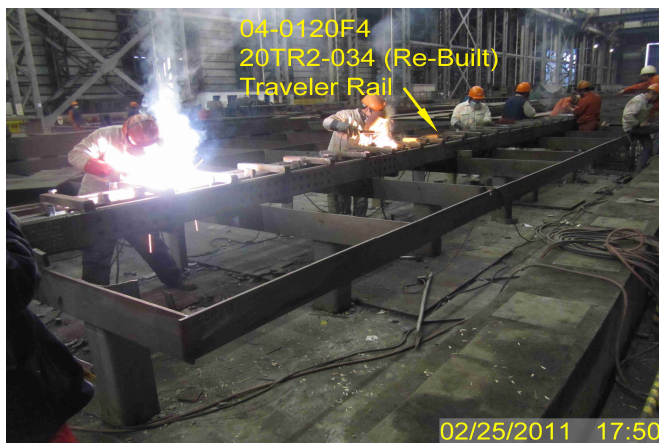
This QA inspector observed ZPMC in process of SMAW welding on Re-Built traveler rail assembly 20TR2-034. ZPMC QC inspector Mao Bin Bin was present at this time of this observation and informed this QA inspector of the work that is in process and identified Zhao Chen Sun as the CWI. It was stated that ZPMC had 5 welders and identified the welders by ZPMC welder identification number appointed to then by ZPMC. This QA inspector verified this information for the following location;

The following digital picture illustrates the welding of the Re-Built traveler rail.
